Záchrana varhan a výzdoby kostela
Nanebevzetí Panny Marie ve Vranově nad Dyjí

Preservation of Pipe Organ and Church Decorations
of the Church of the Assumption of the Virgin Mary

A. D. 2011

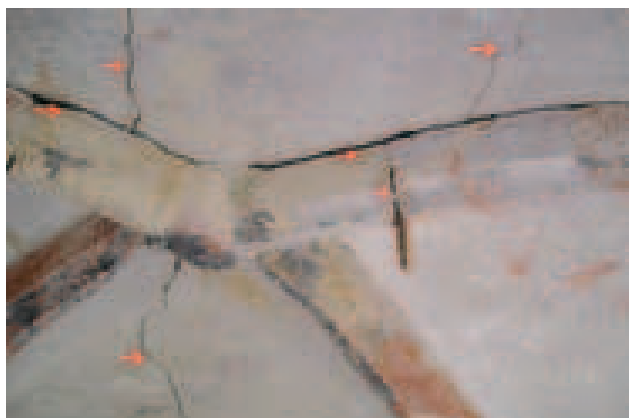
Plošný odkryv vrstev na křížové klenbě v presbytáři, vyznačení statických trhlin. / Large area removal of the surface layers on the rib-groined vault of the presbytery, marking the settlement cracks. Foto Václav Holoubek

Malba je v poměrně dobrém technickém stavu. Tektonická vertikální prasklina přes střed klenby presbytáře je stabilizovaná a podle jejího stavu a rozestupu, který je menší než 1 mm, od posledního tmelení v roce 1934 se není nutno obávat nějaké havárie. Lze však předpokládat, že stávající trhlinka do 1 mm se na fresce bude objevovat i v budoucnu po restaurování, jelikož se jedná pravděpodobně o nepatrné změny pnutí klenby vlivem změn teplot v zimním a letním období. Ostatní trhliny v malbě jsou zanedbatelné a vlastní malbu nijak neohrožují. Tmely a retuše v tektonické trhlině, na to že byly provedeny již v roce 1934, jsou nevypadané, ale v současnosti poněkud ztmavlé či částečně odpadlé a tmel přes ně prosvítá. Retuše jen částečně přechází i přes původní malbu, někde však ve větším rozsahu v šíři 2–7 cm.

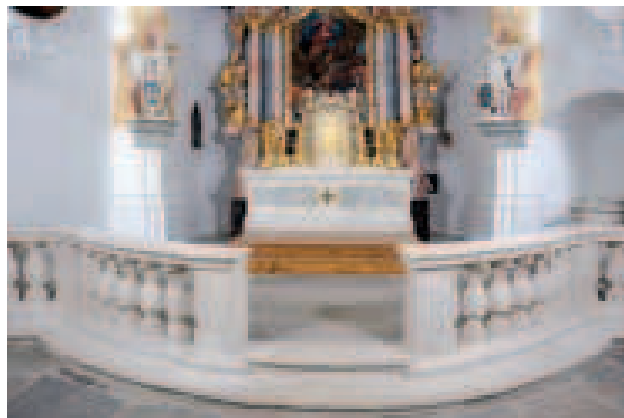
Chórová přepážka. Stav po restaurování. / Choir partition, after restoration. Foto Kamil Till

After re-laying the original paving, the choir partition in the presbytery was restored. It was cleaned and any defects were filled with artificial stone, the structure and characteristics of which were similar to the original stone around them. The surface was locally retouched using light-resistant pigments.

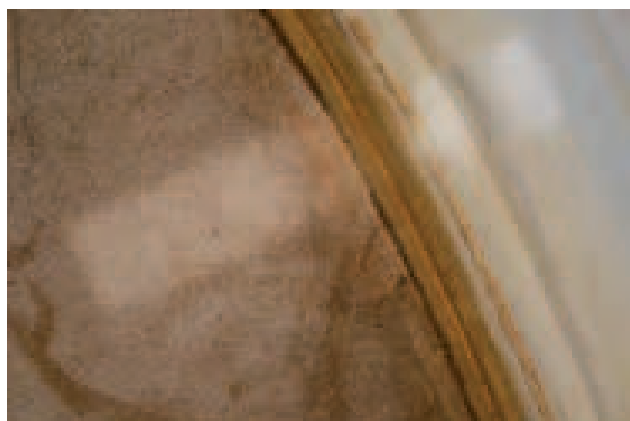
Sonda ve vrstvě nečistot a přemaleb na štukovém lazurovaném rámu. / Dirt and over-paint layer probe of the stucco-decorated glazed frame. Foto Radomír Surma

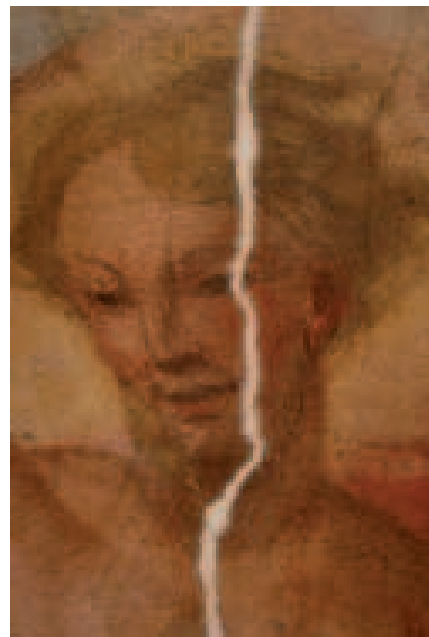
Stav po očištění a vytmelení tektonické trhliny. / Situation after cleaning and filling the tectonic crack. Foto Radomír Surma

odpadnutím. Tektonická trhlinka nebyla stabilizována staticky, protože nebylo provedeno statické zajištění klenby. Podle drobné trhlinky, která se na stavu před restaurováním objevila od roku 1934, však není nutno mít přílišné obavy z náhlých posunů klenby. Drobné pohyby po restaurování však v důsledku klimatických změn, zejména vlhkosti obsažené ve zdivu a tepelné roztažnosti materiálů v ročním cyklu zima/léto, nelze vyloučit. Dá se předpokládat, že drobná trhlinka se i po restaurování po několika sezónách znovu objeví.

Právě z důvodu hluboké tektonické trhliny byl použit na vytmelení defektů trhlín lehčený šlehaný pružný tmel, který lze tmelit i do velkých hloubek defektů, protože díky šlehané struktuře a porezitě s bublinkami nedochází ke smršťování, nebo je alespoň částečně eliminováno. Tento tmel je však hladký a nelze do něj přidat hrubé ostřívo, které by napodobilo hrubě filcovaný povrch okolního originálu, protože by tmel ztratil své vlastnosti. Tato skutečnost alespoň doplněný hladký tmel jednoznačně odlišuje

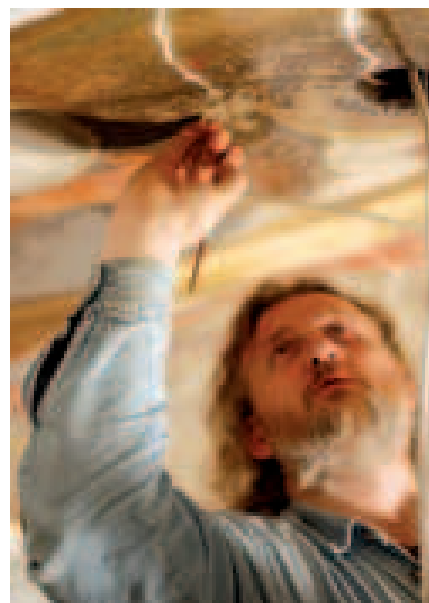
Práce na odlišitelné retuši vytmelených defektů trhlín. / Working on the discernible retouching of the filled crack defects. Foto Jakub Kmošek

od výrazně hrubého originálu. Tmel je ve finální fázi nanesen tzv. od hrany po hranu (aby nebyl překryt originál malby), takže je na některých místech mírně či více „zešikma“, protože klenba je sesedlá na každé straně trochu jinak a tento rozdíl činí místy i 1,5 mm, což je na trhlinu o šíři 3–8 mm poměrně hodně. Je možné, že při proměnlivém bočním svitu slunce do presbytáře v průběhu roku a při bočním umělém nasvětlení může docházet v těchto místech k jistým stínům trhliny, což je fakt, se kterým je nutno se smířit, nebo se pokusit jej eliminovat podélným nasvětlením klenby ve směru trhliny, nebo nasvětlením prostorovým či odraženým.

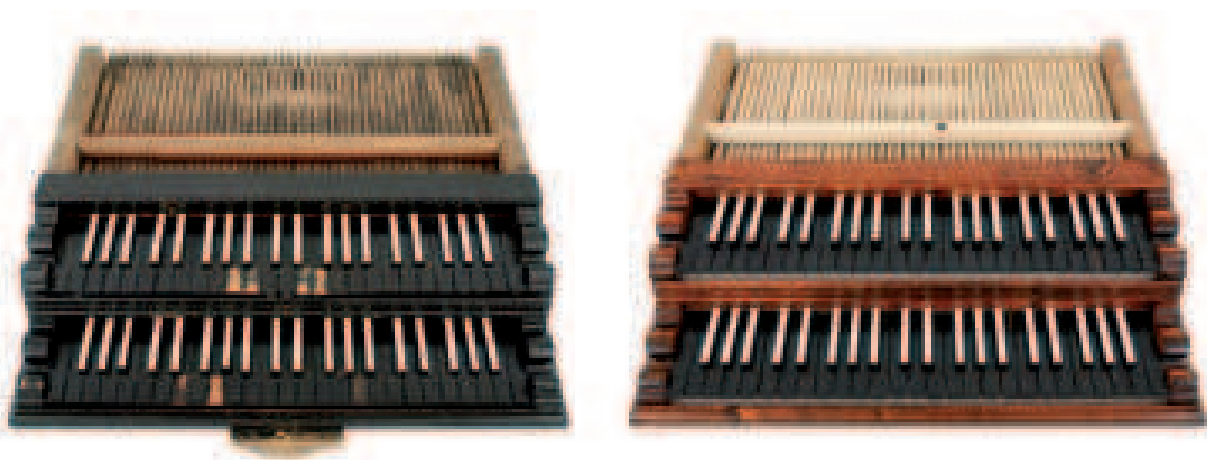
Manuálové klaviatury před a po restaurování. / Manuals before and after restoration. Foto Dalibor Michek

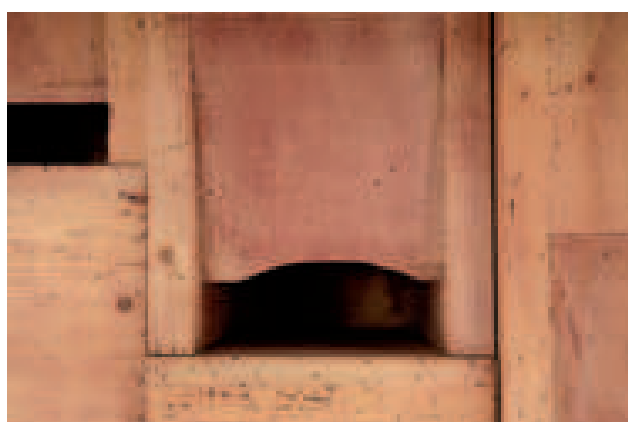
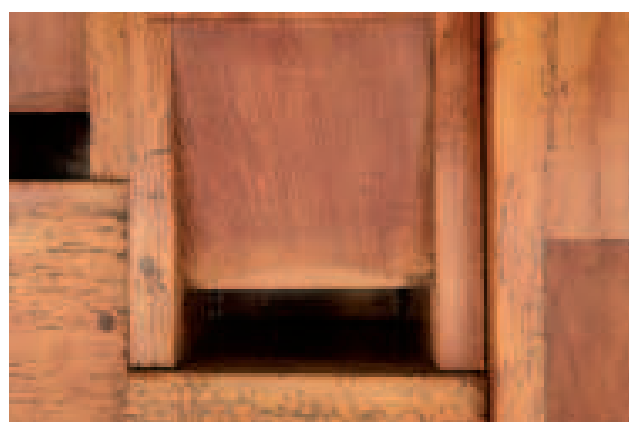
Labium píšťaly G Subbasu 16' před a po doplnění výřezu. / Lips of the G Subbass 16' pipe before and after the lowering of the cut-out. Foto Dalibor Michek

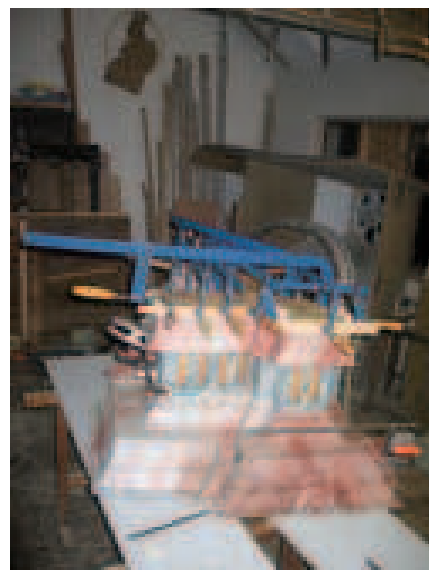
Hlavní oltář. Klížení uvolněných částí hlavní římsy rozebraného oltáře. / High altar. Gluing the released parts of the main ledge of the dismantled altar. Foto Pavel Hanč

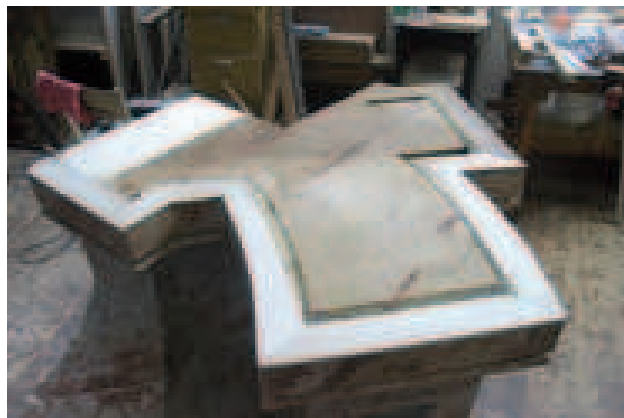
Hlavní oltář. Postupné nakližování říms na konzolový díl. / High altar. Gradual gluing of the ledges to the console section. Foto Pavel Hanč

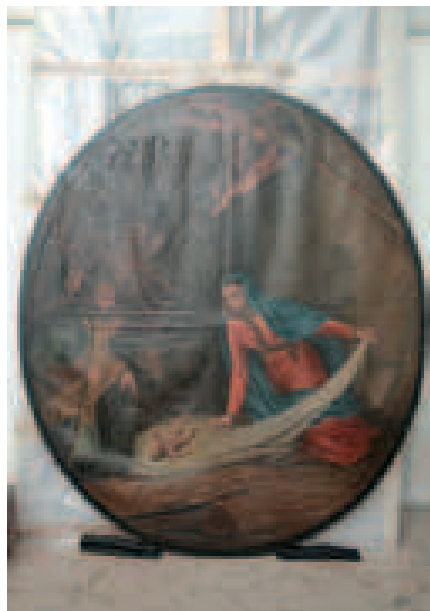
Narození Krista. Stav před opravou. /
The Nativity of Christ, before repair.
Foto archiv autorek / authors' archive

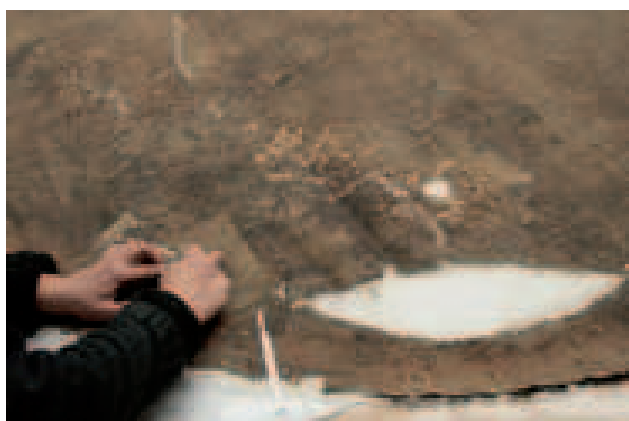
Narození Krista. Rubová strana obrazu po sejmutí nevyhovujícího podlepení, čištění od zbytků lepů a starých záplat před scelením trhlin a doplněním chybějícího plátna. / *The Nativity of Christ*. The rear side of the painting after removal of unsuitable support, remaining glue and patches and before filling up the crackles and adding missing canvas. Foto archiv autorek / authors' archive

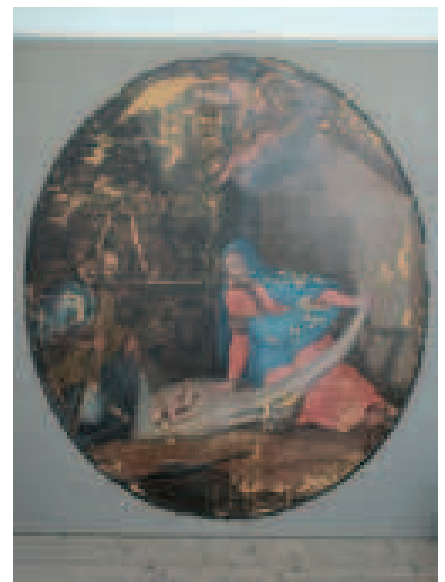
Narození Krista. Stav v závěru opravy před retuší – dublovaný obraz byl přepnut na nově zhotovený rám, barevná vrstva očištěna, zbavena přemaleb a zpevněna, defekty vyplněny vsadkami plátna a emulzním tmelem. / The Nativity of Christ. Painting repair – before the final retouching, painting with replaced support tightened up on a new frame, coloured layer cleaned and reinforced, defects filled with canvas inserts and emulsion filler. Foto archiv autorky / authors' archive

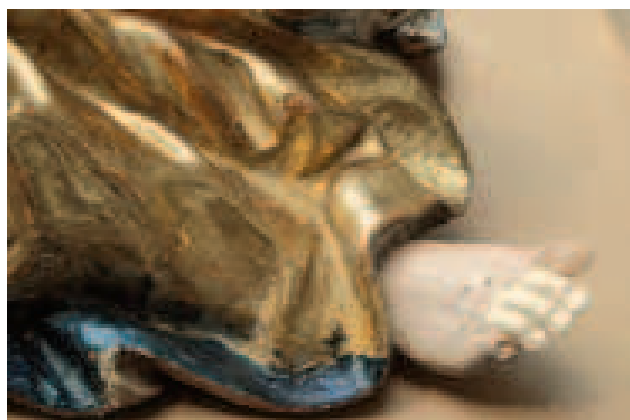
Plastika Boha Otce, dořezba chybějících prstů. / Sculpture of God the Father, additional carving of missing fingers. Foto archiv autorky / author's archive

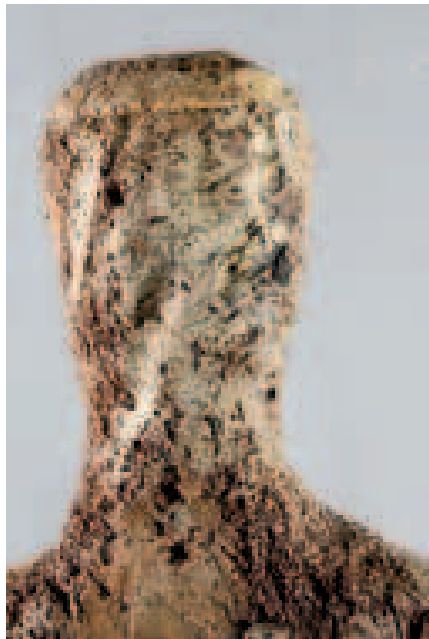
Stav po sejmutí přemaleb a tmelů. Hlava Madony zezadu, zbytky záhybů roušky s fragmenty polychromie. / Situation after overpaint and filler removal. Head of the Madonna from the rear, remains of headscarf pleats with polychromy fragments. Foto Markéta Pavlíková

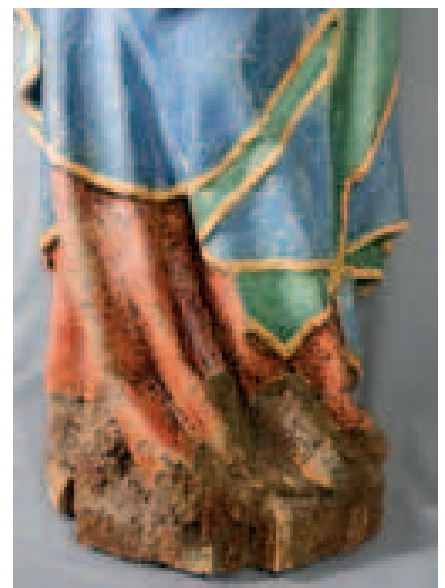
Stav po sejmutí přemaleb. Spodní část šatů Madony, ulomený cíp draperie kryje polychromie a plátěná bandáž. / Situation after overpaint removal, broken-off drapery tail covered by polychromy and canvas bandage. Foto Markéta Pavlíková

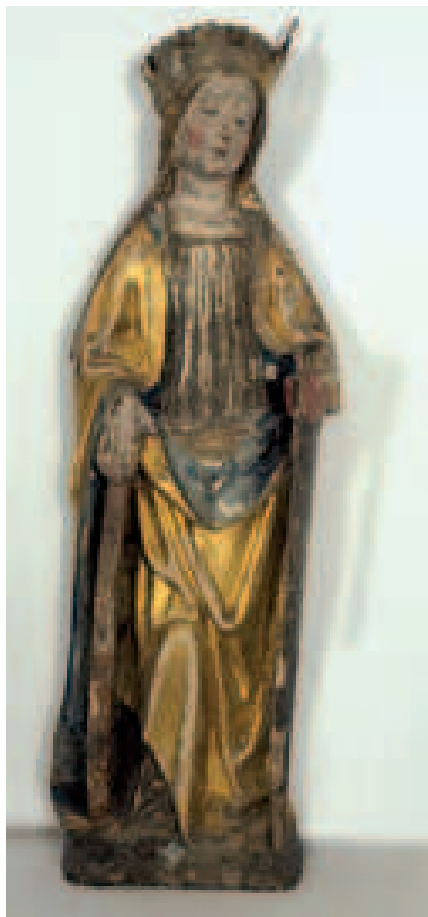
Sv. Kateřina z Vardø. Stav před restaurováním. / St. Catharine from Vardø before conservation. Foto archiv autorky / author's archive

kovené oblasti oprýskané, nebo se začínají odlupovat. Plastika je tedy ohrožená a restaurování je naprosto nezbytné.
