Záchrana varhan a výzdoby kostela
Nanebevzetí Panny Marie ve Vranově nad Dyjí

Preservation of Pipe Organ and Church Decorations
of the Church of the Assumption of the Virgin Mary

A. D. 2011

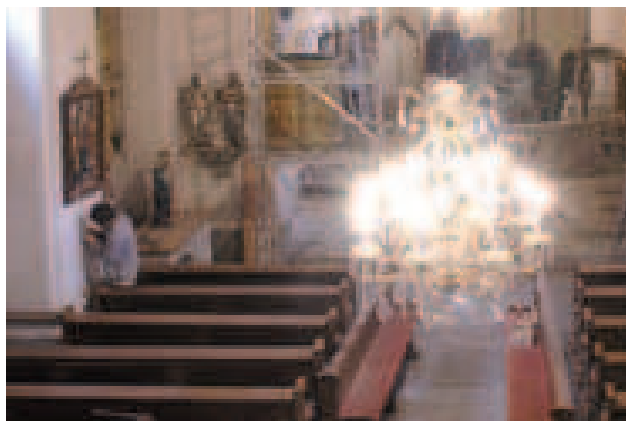
Sondážní průzkum a odběr vzorků pro stratigrafický průzkum povrchů stěn a klenby kostela. / Probing survey and the taking of samples for a stratigraphic survey of the finishes of the walls and the vault. Foto Václav Holoubek

1. Při odkryvu byly odkryty nejstarší středověké omítky s barevnými vrstvami na stěnách pocházejícími z dnes zazděných oken a také byla potvrzena existence středověké dekorativní malby po stranách kamenného sanktuária v presbytáři kostela.

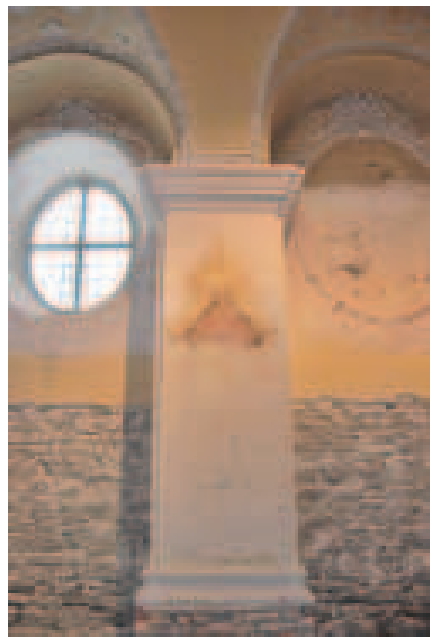
Plošný odkryv stěn a odstranění druhotných omítek. / Large area removal of the secondary plaster layers. Foto Václav Holoubek

Postupný odkryv prokázal výrazné statické narušení omítek v celém interiéru. V rámci obnovy ploch klenby a stěn byl na kontrolním dnu z iniciativy zástupců NPÚ, ú. o. p. Brno a MěÚ Znojmo upraven postup prací a barevná prezentace – štuková výzdoba i pasivní plochy byly obnoveny v bílé barevnosti a restaurovány, resp. rekonstruovány baldachýny na pilastrech a na pravé straně presbytáře, čelní strany pilastrů byly tónovány. Rekonstrukce baldachýnů proběhla v místech, kde již dříve byla omítka otlučena až na zdivo (pilastry na levé straně). Historická (původní) technologie štukové výmalby byla provedena technikou secco malby na vápenných omítkách a podkladové líčce. Obnova v původních technologiích nebyla vzhledem k havarijnímu stavu omítek možná. V první fázi byly kotveny nejvíce uvolněné plochy a kaverny injektovány Ledanem. Zvětralá omítka se kvůli kotvení (aby vůbec unesla sebe samu) musela konsolidovat hloubkovou paropropustnou penetrací HERBOL – IMPRÄGNIERGRUND, která zajišťuje i odolnost proti plísním. Na takto připravený podklad byla malba restaurována reverzibilním způsobem křihovou temperou.

Restaurátorská obnova byla ovlivněna zvoleným technologickým postupem, který se soustředil na konsolidaci omítek, nikoli na obnovu v původních technologiích. V intencích zvolené metody byly dotčené plochy omítek v závěrečné fázi zakryty celoplošnou výmalbou v lomené bílé. Šedě natřené pohledové strany pilastrů a malby baldachýnů naznačují barokní výmalbu.

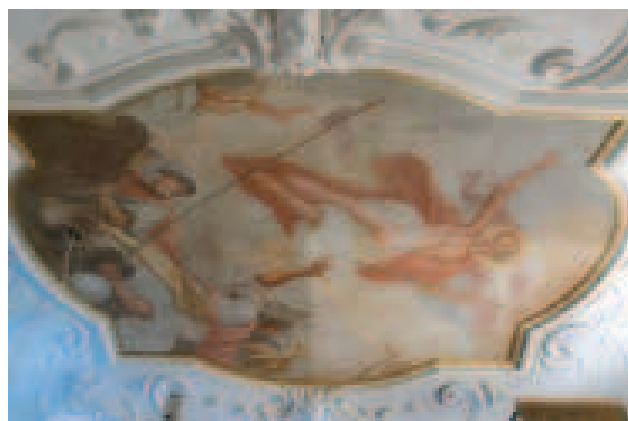
Stav po očištění čtvrtiny povrchu malby. / Situation after cleaning a quarter of the painting surface. Foto Radomír Surma

Po fotodokumentaci a průzkumu jsem přistoupil k postupnému snímání povrchových nečistot průzkumem ověřenou optimalizovanou směsí tenzidů a enzymů. Čištění bylo provedeno vatovými tampony na pinzety ve dvou časových segmentech s různou koncentrací roztoku. Konzervace polymerovaným olejem nebyla narušována a ani snímána pro její dobrou funkci a minimální barevnou změnu tónu či žloutnutí. Lokální větší nečistoty pod polymerovaným olejem byly redukovány špičkou skalpelu. Retuše a lokální přemalby temperou na tektonické trhlině a po obvodu malby (tmavě hnědá linka) byly po naměkčení tenzidem dočišťovány skalpelem. Po očištění malby má povrch barev lesklý charakter (pozorováno v protisvětle), což je způsobeno celoplošným nátěrem polymerovaným olejem pravděpodobně v roce 1934. Barvy jsou syté a výrazné a působí čerstvým dojmem teplých intenzivních barokních odstínů, a to přes dílčí povrchové poškození malby v minulosti. Odstraňování polymerovaného oleje by bylo nesmírně riskantní z důvodu možného dalšího poškození secco emulzní malby, která byla pravděpodobně před touto fixací z roku 1934 zpráškovatělá. Lze říci, že tato trvalá fixace malbě z dlouhodobého hlediska svědčí a bezpečně ji chrání, i když se v současnosti tato konzervační technika nepoužívá (pro jasné změny po aplikaci tohoto časem žloutnoucího materiálu u barevných odstínů od chladnějších k teplejším). Je možné také říci, že díky této fixaci nedošlo při současném restaurování k sebemenšímu poškození barev a struktury malby originálu. Po očištění malby byly odstraněny z tektonické trhliny veškeré tmely, které neměly bezpečnou přilnavost k hranám defektu. Ukázalo se, že cca 98 % tmelů nemá soudržnost s originálem, protože byly nanášeny bez upevnění a jen měly v tloušťce jen několik mm, přestože trhlina jde do hloubky několik centimetrů.

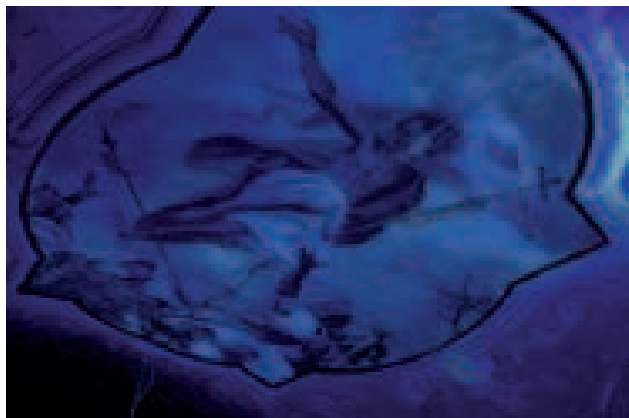
UV luminiscence, povrch malby natřený polymerovaným olejem. / UV luminescence, painting surface coated with polymerised oil. Foto Radomír Surma

zaznamenány dvě různé vrstvy nečistot. Mladší vrstva je volná a nefixovaná k povrchu a lze ji snímat čistou vodou. Starší vrstva je mastná dehtová, ulpělá a snímání je možné pouze při použití optimalizovaného roztočku tenzidů a enzymů ve vodě. Vlastní malba je díky konzervaci polymerovaným olejem z roku 1934 (viz níže) vodě odolná. Malba v sondách je podstatně jasnější, v mnoha případech je barevnost pozměněná a pod nečistotou nečitelná, zejména chladné namodralé a nazelenalé odstíny s bělobou, které nejsou pod nečistotou vůbec vidět. Změna barevnosti se však týká všech barev včetně intenzivní červeně na plášti Krista, která je pod

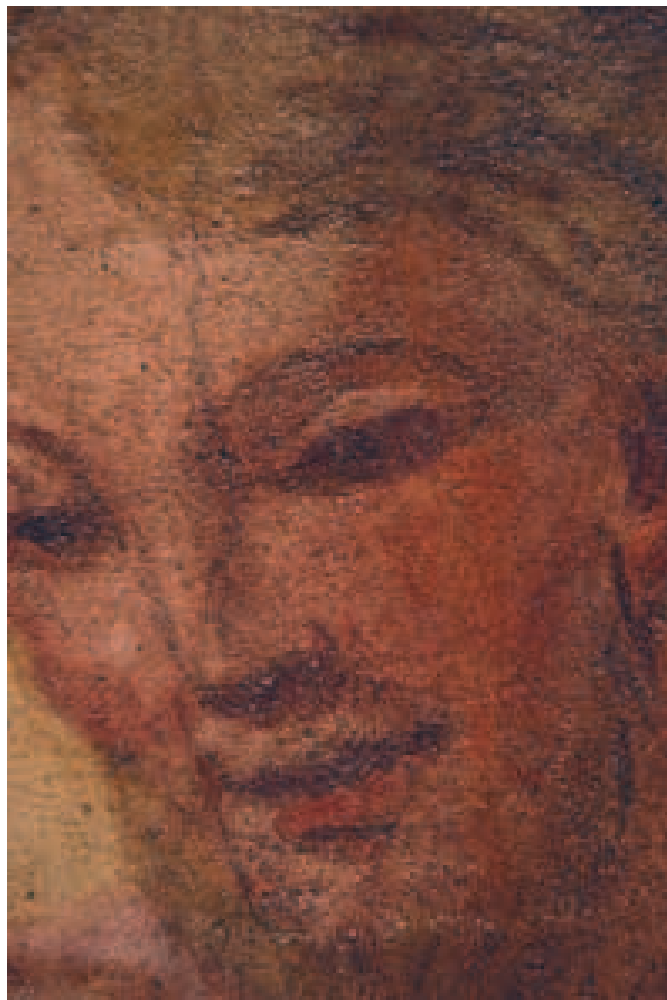
Stav po restaurování, odlišitelná struktura retuše. /
Discernible retouch structure, after restoration. Foto
Radomír Surma

Retuš tmelených defektů a drobných rušivých defektů odpadlé barevnosti až na podkladní omítku je provedena retušovacími barvami Maimeri v odlišitelné čárkové struktuře tak, aby se tím pokud možno co nejvíce vizuálně napodobila hrubá struktura okolní omítky. Struktura

„trateggia“ je však natolik jemná, že již ze vzdálenosti cca 60 cm není téměř čitelná a z podlahy presbytáře není vidět vůbec.

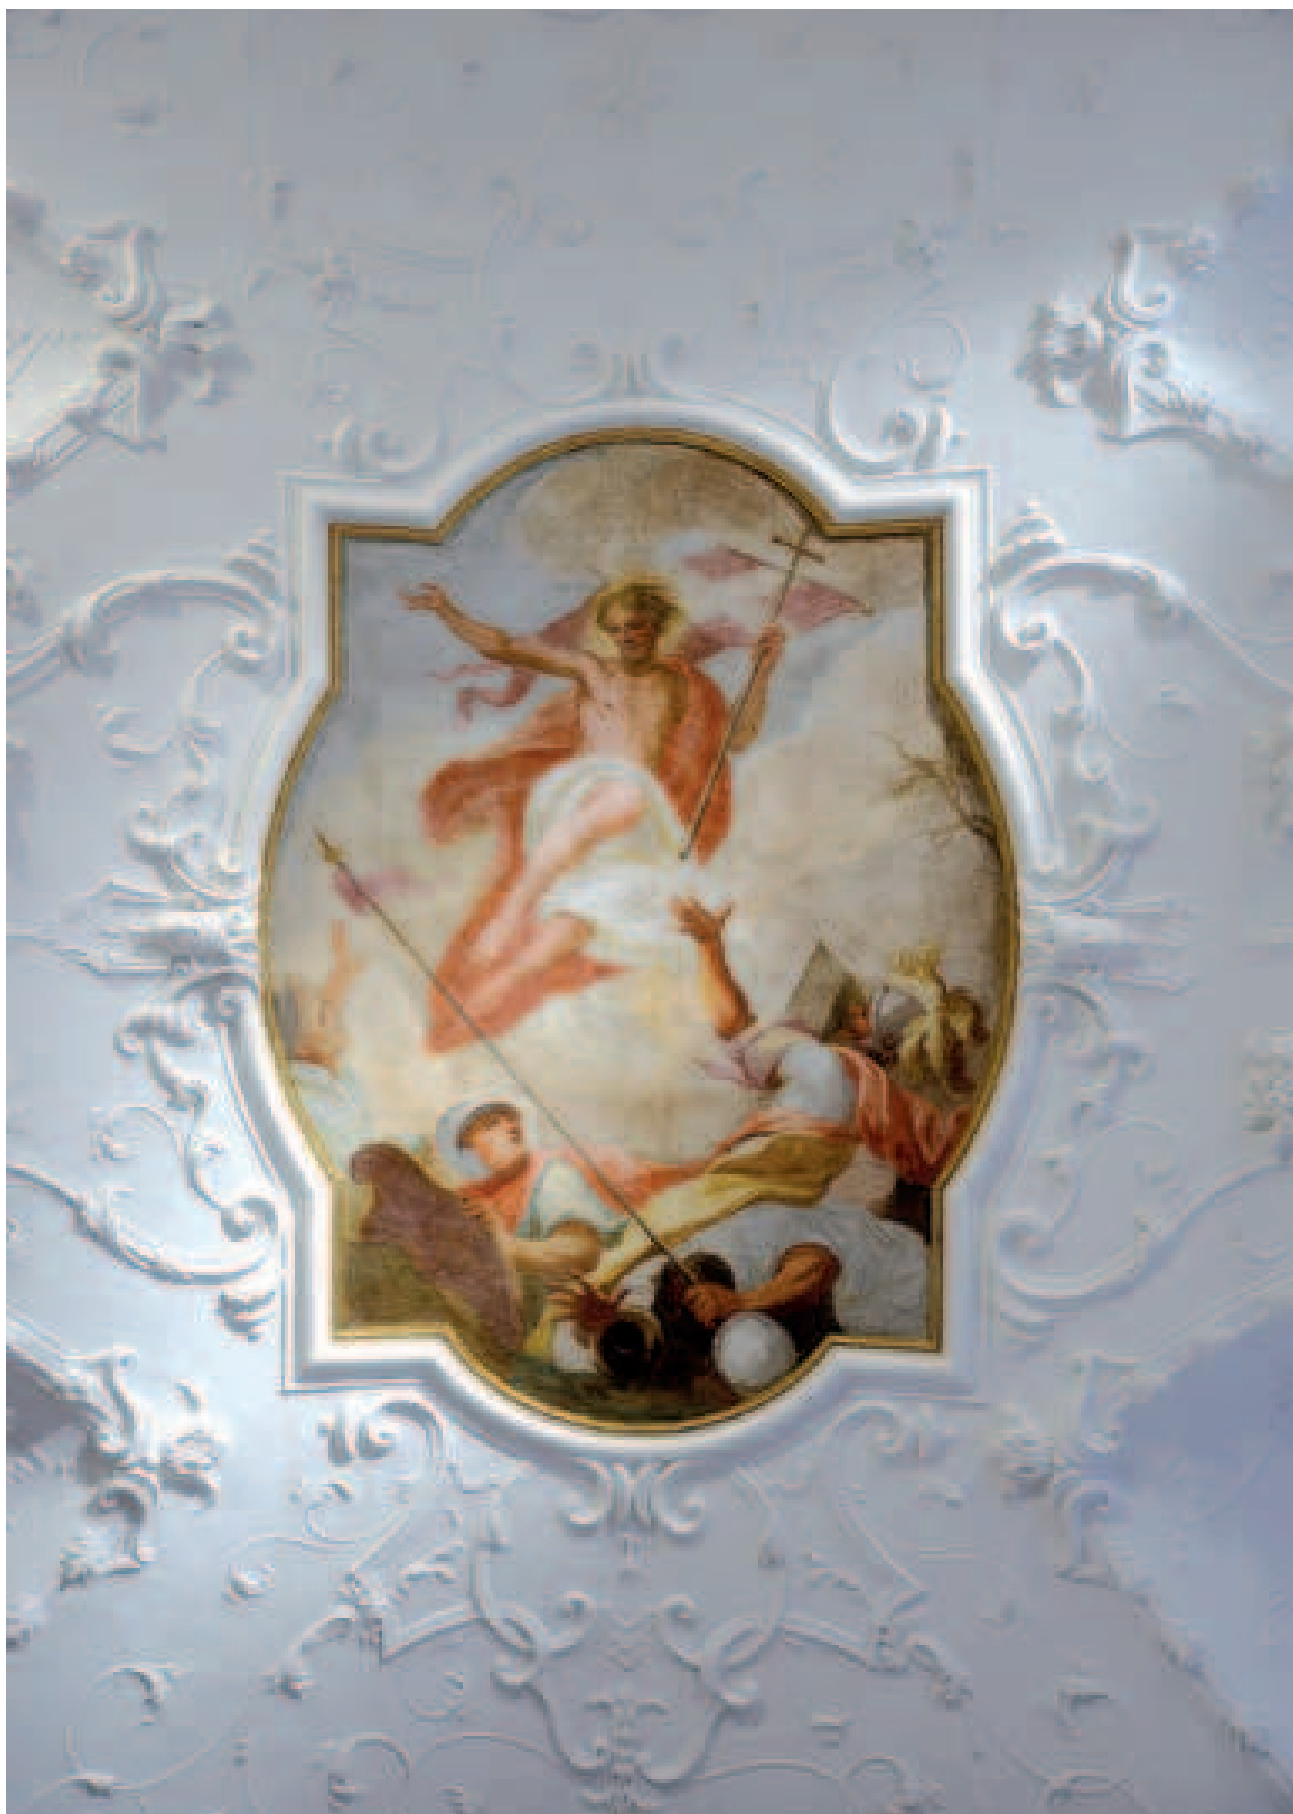
The painting is in relatively good technical condition. The tectonic vertical crack through the middle of the vault of the presbytery is stabilized and based on its state and span of less than 1 mm from the last filling in 1934 there is no need to fear an emergency. It can be expected that the existing crack of up to 1 mm will reappear in the fresco in the future even after restoration as it is probably caused by minute changes in the stressed vault due to temperature variations in summer and winter. The remaining cracks in the painting are negligible and present no danger to the painting itself. Fillers and retouches in the tectonic crack, despite being made in 1934, are still in place, although they are presently darker and where parts of them have fallen off the filler shows through. The retouches only partly extend over the original painting, although in some locations the extent may be greater, between 2–7 cm.

Zmrtvýchvstání Krista. Stav po restaurování. / The Resurrection of Christ, after restoration. Foto Kamil Till

or structure of the original painting. After the painting had been cleaned, all fillers from the tectonic crack that did not safely adhere to the edges of the defect crack were removed. It was discovered that approx. 98 % of fillers had no adherence to the original as they were applied without fixing and only in a shallow layer of a few millimetres, although the crack runs several centimetres deep.

In this phase after the painting and foundation were completely dry the disrupted paint and conservation with polymerised oil were fixed and their surface reinforced. The fixation was carried out using an optimum thin solution of paraloid. This was followed by deep fixation and injection of the tectonic crack defect, consisting of attaching the plaster layer to the original plaster with whitewash and fastening the original plaster to the masonry using Ledan and the Hydrogrund acrylic dispersion, if the particular spot was loose and about to fall off. The tectonic crack was not stabilized structurally as the vault was not structurally reinforced. Judging from a small crack that appeared before restoration compared to the condition in 1934, there is no need to worry about sudden movements of the vault. However, minor shifts after restoration due to climatic changes, in particular moisture contained in the wall and material expansion/contraction within the summer/winter annual cycle cannot be ruled out. It can be expected that a minor crack will reappear after several seasons even after restoration.

As the tectonic crack runs deep we used expanded whipped flexible filler to fill the defects. It can be applied to a considerable depth and thanks to its whipped structure and porosity with bubbles it is not prone to shrinking or it is at least partially eliminated. However, the filler is smooth and it is impossible to add coarse particles to it as the filler would lose its properties. In the final phase the filler is applied from edge to edge (so as not to cover the original material), so that in some places it is slightly or more pronouncedly “sloped” due to the differences in the vault sagging on each side of the crack and this difference may amount even up to 1.5 mm, which is quite a lot for a crack 3–8 mm wide. It is possible that with the changing side illumination by the sun in the presbytery during the year and with side illumination by artificial lighting the crack might cast something of a shade in these locations, which is a fact that either has to be put up with or can be tentatively redressed by experimenting with lengthwise illumination of the vault in the direction of the crack or spatial/reflected illumination.

The retouching of the filled-in defects and the minor disruptive defects of colours flaked off from the foundation plaster were made using Maimeri retouching colours applied with a discernible line structure in order to visually imitate the coarse structure of the surrounding plaster, although the structure of the “trateggio” is so fine that from a distance of 60 cm it is almost unnoticeable and from the floor of the presbytery it is invisible.

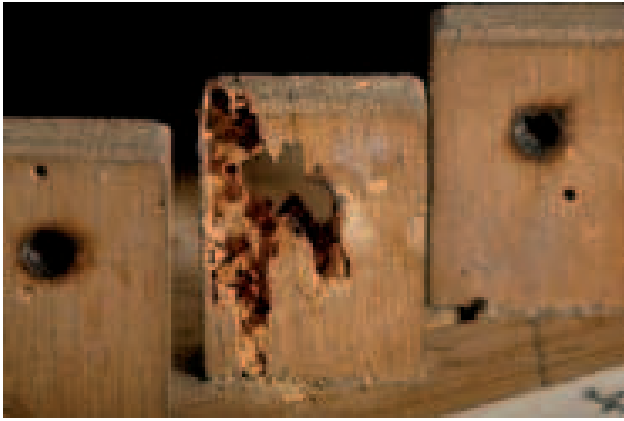
Poměrně veliké bylo poškození varhan červotočem, píšťaly byly navíc v minulosti částečně polepeny papírem a natřeny červenou barvou, kterou bylo nutno odstranit. Postižené dřevěné části byly zpevněny v lázni akrylátové pryskyřice, výletové otvory byly zatmeleny voskovou směsí. Díly poškozené neopravitelně musely být rekonstruovány.

Panenka hřidelové desky hlavního stroje zcela zničená červotočem. / Rollerboard of the main division completely destroyed by woodworm. Foto Dalibor Michek

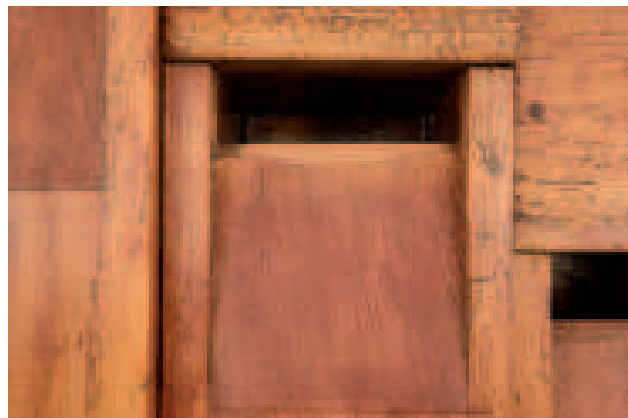
Aside from the assorted damage, many pipes were badly affected by the non-original raising of the upper lip cut-outs, which have a profound impact on the attack and the timbre of the tone.

Restaurované labium varhan v kostele Nanebevzetí Panny Marie ve Vranově nad Dyjí. / Restored labium of the organ in the Church of the Assumption of the Virgin Mary in Vranov nad Dyjí. Foto Petr Koukal

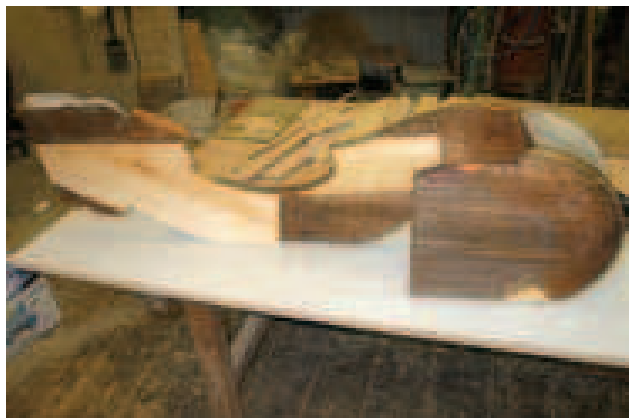
Hlavní oltář. Detail voluty v průběhu opravy. / High altar, detail of the volute during repair. Foto Pavel Hanč

The high altar of the Assumption of the Virgin Mary from 1720–1730, with a sanctuary from around 1770, consists of portal architecture with an attachment divided up by rich sculptural decoration. Upon dismantling it was revealed that the supporting structure had been completely destroyed by ligniperdous insects. After consultation with NPÚ (National Heritage Institute) representatives it was decided to make a new structure with dimensions corresponding to the original. The dismantled parts were released from the loose joints, petrified and after repair they were again glued together and fixed with wooden nails. Degraded or missing parts were replaced. Cracks were repaired,

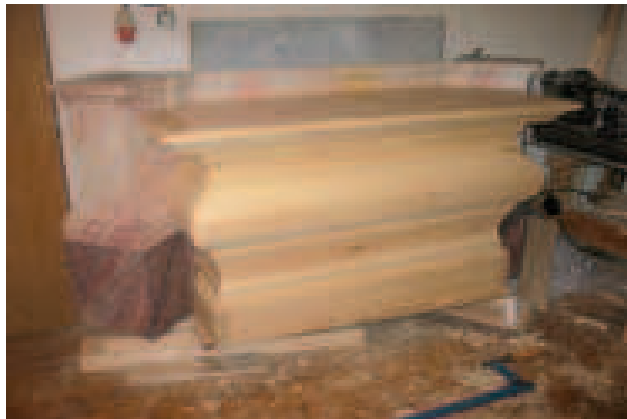
Oltář sv. Jana Nepomuckého. Nově zhotovená menza před polychromováním. / Altar of St. John Nepomucen. Newly built mensa before polychromy. Foto Pavel Hanč

Altar of St. John Nepomucen from 1720–1730, of the portal type, is situated at the victory arch opposite the pulpit. In the past the mensa had been removed and replaced with a simple slab. The altar wood had shrunk from dryness, had been attacked by woodworm and the boards in contact with the floor were completely destroyed. During repair the destroyed sections of the wooden mass had to be cut off and new material was plated onto the sound wood. The cabinet-makers' restoration work then continued in a similar way to the architecture of the high altar. Based on the preserved outline in the bottom part, a new mensa of

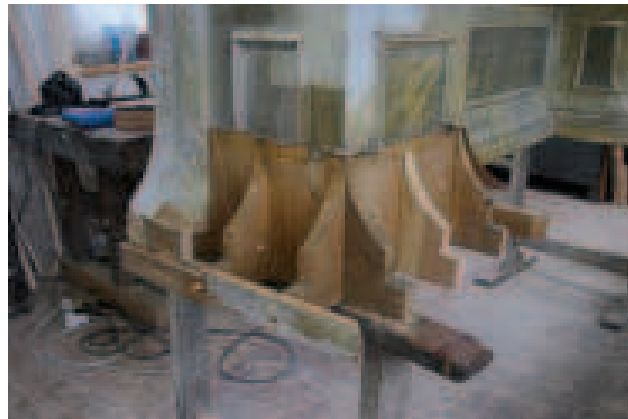
Oltář sv. Barbory. Uvolnění konkávní části středního dílu a opětovné sklížení. / Altar of Sr. Barbara. Releasing the concave part of the middle section before re-gluing. Foto Pavel Hanč

The restoration of the central parts of the side altars was a demanding task. Regarding the parts from the altar of St. Joseph it was decided to remove the concave parts that had been destroyed in the past and had been replaced without expert knowledge with a different material of inferior quality. These were reconstructed based on the preserved parts on the altar of St. Barbara and incorporated some surviving sections of the ledges and laths. The rear panel of the attachments was repaired and where completely destroyed, the material was replaced with new material. The corpuses of the pillars were glued together and the repaired laths and ledges were glued to them. In St. Barbara the concave parts were attached to the ribs using small pegs and glue. The laths, ledges and individual parts were fixed as they had been originally by wooden nails.

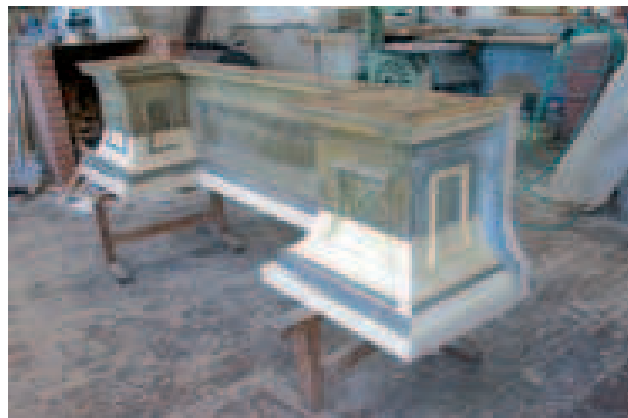
Oltář sv. Josefa. Střední díl po rekonstrukci. / Altar of St. Joseph. Middle section after reconstruction. Foto Pavel Hanč

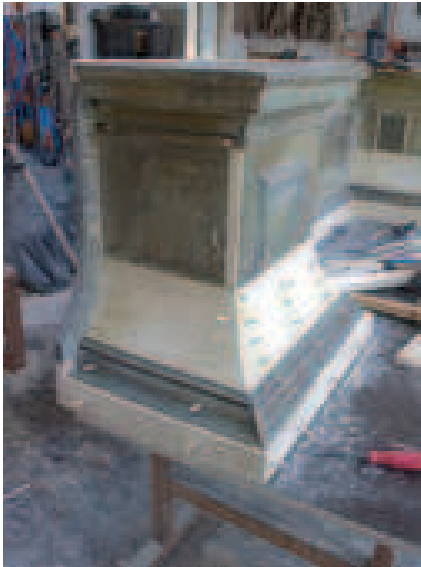
Oltář sv. Josefa. Střední díl po doplnění. / Altar of St. Joseph. Middle section complete with additions. Foto Pavel Hanč

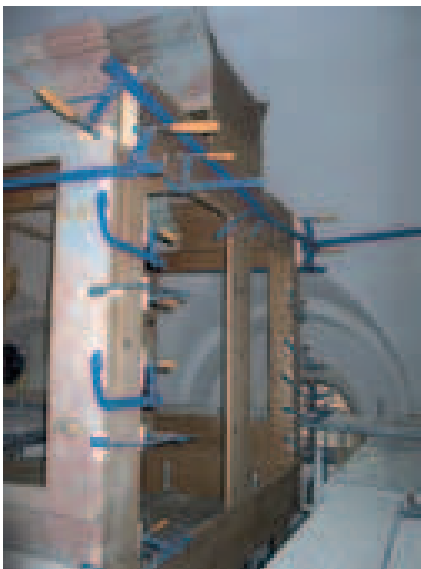
Varhanní skříň. Klížení rámové konstrukce. / Organ case. Gluing the framework. Foto Pavel Hanč

The organ case with the console and the Positive was made by Josef Silberbauer in 1778. After dismantling the organ machine the structure became unstable due to the damaged frame in the bottom section where the tenons were broken as a result of incompetent intervention during additional modifications of the wind conduits. After consultations with an organ builder it was decided which holes would be covered by plates and where the new passages for the wind conduits would be. The wood of the organ architecture and structure

was infested with woodworm, the individual parts were loose, shrunken by dryness and in places temporarily fixed by nails. The ledges were indented and the individual panels had cracks.

Given the unstable structure of the bottom section the organ case was braced with obliquely placed planks so that it would not collapse and to allow for framework of the bottom section of the case to be repaired. The individual parts of the framework were repaired by overplating with the plates sunken into the material so that they would not hinder the return of the playing mechanism. In the bottom section, where the batten of the structure was broken by the wind conduits, the material was patched so that a new opening for the wind conduits could be cut. The broken tenons and battens of the bottom structure in its upper section were ground down and replaced by new material in the thickness of the frame. After repairing the individual frames they were glued together and secured with new wooden nails, as the original ones were completely destroyed by woodworm and broken by the movement of the loose case. Only after fixing this was it possible to remove the bracing and continue with repairs to the upper part. The framework of the upper part had shrunk from dryness, it had loose joints and the laths and ledges were also loose. After gluing together the individual frames and securing them with wooden nails, the laths were glued on and the dismantled ledges were mounted on their original position.

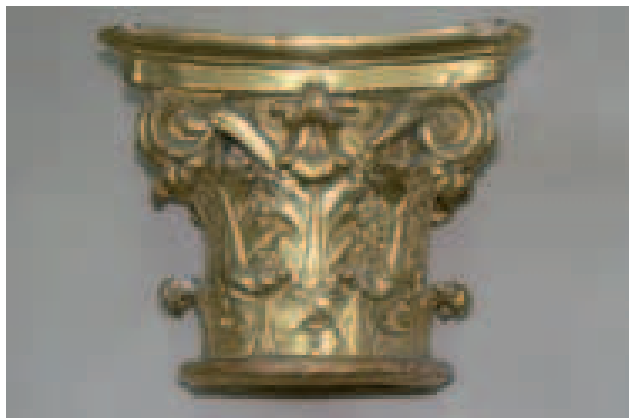
Zlacená hlavice z oltáře sv. Jana Nepomuckého. Stav před restaurováním. / Gilded capital from the altar of St. John Nepomucen, before restoration. Foto archiv autorů / authors' archive

The gilding of the altar architecture, including the altar tables and the sanctuary of the high altar, was loose and in places completely missing. The chalk layer was partly degraded due to the high moisture content. The gilding itself was made to a high quality, although it obviously originated from a later period, as confirmed by the colour of the poliment (orange-yellow). The secondary gilding therefore partly suppressed the modulation of the carving that had been created by adding another layer of chalk. In the matt sections gold was locally replaced with powder bronze bonded in shellac. The gilding on later parts of the architecture of

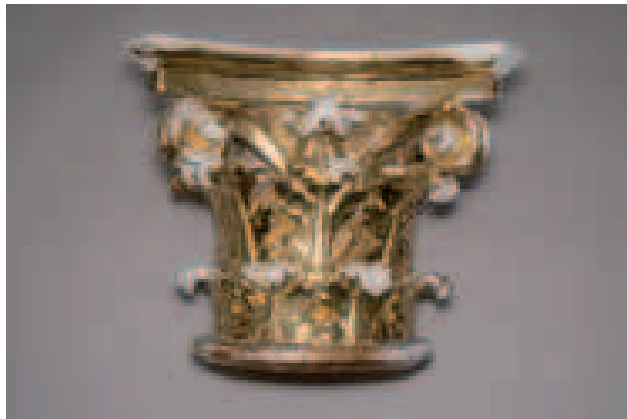
Zlacená hlavice z oltáře sv. Jana Nepomuckého. Stav v průběhu restaurování – křídování. / Gilded capital from the altar of St. John Nepomucen, during restoration – chalking. Foto archiv autorů / authors' archive

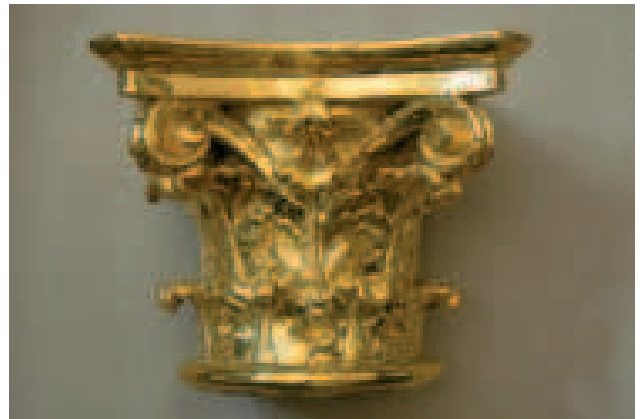
Zlacená hlavice z oltáře sv. Jana Nepomuckého. Stav po restaurování. / Gilded capital from the altar of St. John Nepomucen, after restoration. Foto archiv autorů / authors' archive

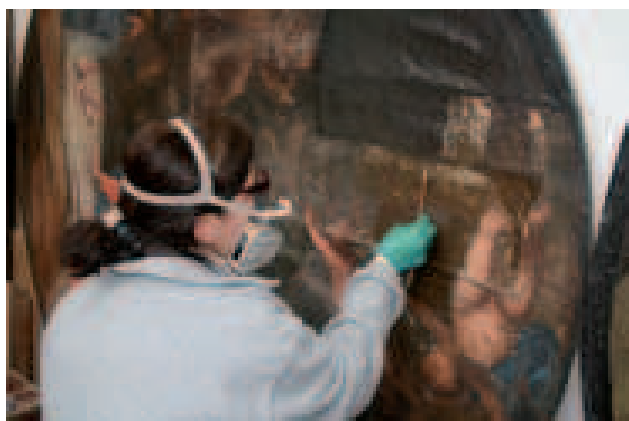
Narození Krista. Postupné snímání přemaleb chemickou cestou. / *The Nativity of Christ*. Gradual overpaint removal using a chemical method. Foto archiv autorek / authors' archive

po vyrovnání a konsolidaci přistoupeno k nažehlení obrazu Beva gelem na nové celolněné plátno a obraz byl napnut na nově zhotovený napínací rám. Malba byla opětovně dočištěna a velké množství defektů bylo vyplněno emulzním tmelem. Tmely byly zabarveny do okrového tónu původního podkladu a povrch upraven tak, aby se nerušeně zapojily do krakelami zbrázděné struktury okolní malby. Scelující retuše rozsáhle poškozené malby byly prováděny akvarelovými barvami, po optickém sjednocení byl obraz poprvé nalakován a následovala další vrstva retuší, tentokrát pryskyřičnými barvami. Na závěr byl obraz opatřen konzervačním lakem z damarové pryskyřice s příměsí běleného včelího vosku a polymerovaného oleje a provedeny již jen malé korektury retuší barvami Maimeri Restauro. Postup prací byl písemně a fotograficky dokumentován.

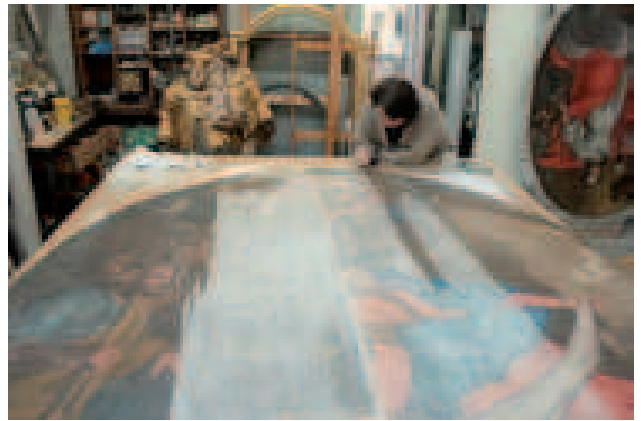
Narození Krista. Po konsolidaci barevné vrstvy byl odstraněn ochranný papírový přelep. / The Nativity of Christ. After consolidation of the coloured layer the protective paper cover was removed. Foto archiv autorky / authors' archive

painting was covered by a sticky protective paper cover, the canvas was removed from the frame and the old additional iron-mounted canvas and patches were gradually removed. On the rear side the original canvas was thoroughly mechanically cleaned of deposits of Kleister and the painting was straightened. Frequent cracks were stitched up using polyamide meltable fibers. Locations with greater defects were repaired using canvas with a corresponding weave and identical foundation applied to it. Afterwards the whole of the painting was consolidated using a Beva solution on a low-pressure vacuum table. As the weave of the old original canvas was not fully coherent, after straightening and consolidation the painting was mounted by ironing using the Beva gel on a new canvas and the painting was strung on a newly made tensioning frame. The paint was again cleaned and the great number of defects was filled with emulsion filler. The fillers were coloured to the ochre tone of the original foundation and the surface was treated so that they would seamlessly blend in with the crackles of the rugged structure of the surrounding paint. The unifying retouches of the extensively damaged paint were done using water-

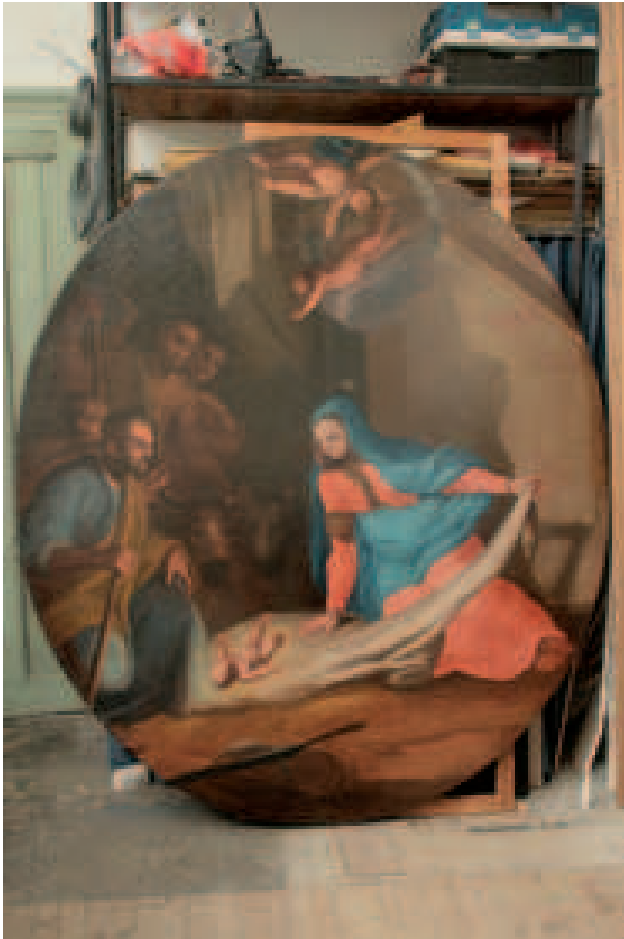
Narození Krista. Stav po opravě před instalací do štukového rámu na evangelijní stěně presbytáře. / The Nativity of Christ. Painting repair – before mounting into the stucco frame on the evangelic side of the presbytery. Foto archiv autorek / authors' archive

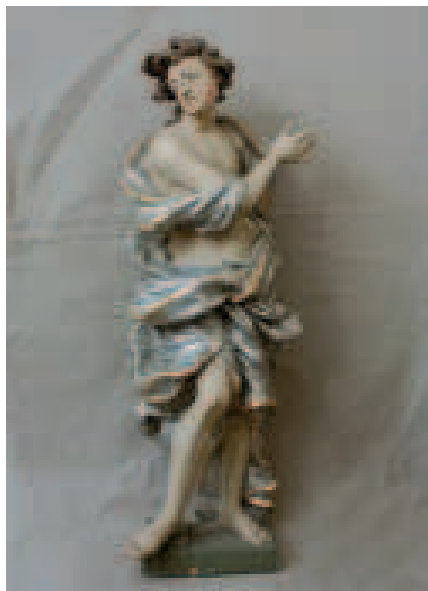
Anděl z oltáře sv. Barbory. Stav před restaurováním. / Angel from the altar of St. Barbara, before restoration. Foto archiv autorky / author's archive

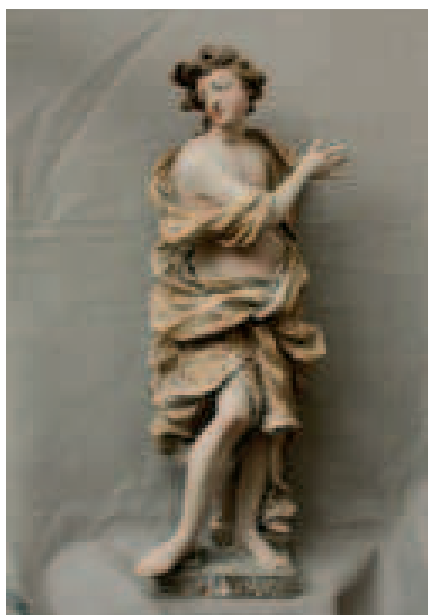
Anděl z oltáře sv. Barbory. Snímání přemalob. / Angel from the altar of St. Barbara. Overpaint removal. Foto archiv autorky / author's archive

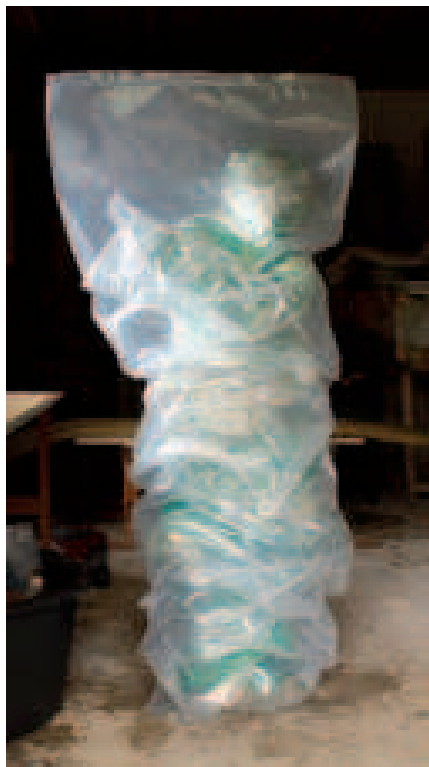
Anděl z oltáře sv. Josefa. Příprava na petrifikaci. / Angel from the altar of St. Joseph. Preparation for petrification. Foto archiv autorky / author's archive

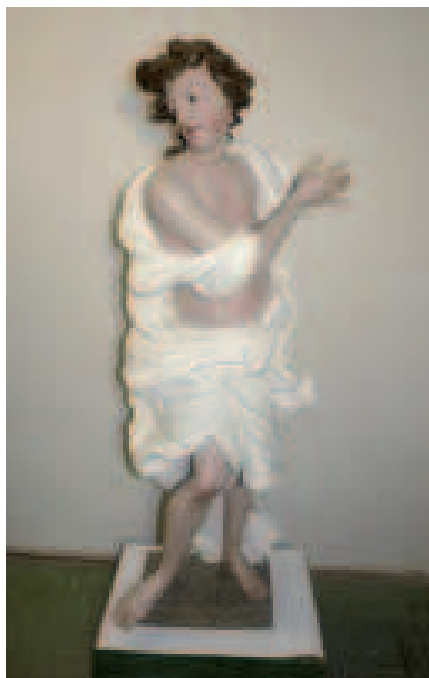
Anděl z oltáře sv. Barbory. Křídlový podklad. / Angel from the altar of St. Barbara. Chalk foundation. Foto archiv autorky / author's archive

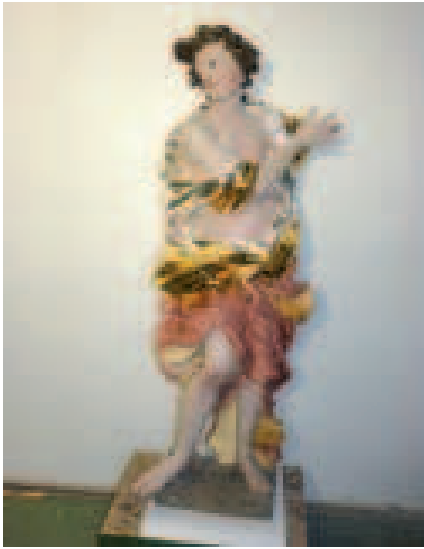
Anděl z oltáře sv. Barbory. Postup při zlacení. / Angel from the altar of St. Barbara. Gilding procedure. Foto archiv autorky / author's archive

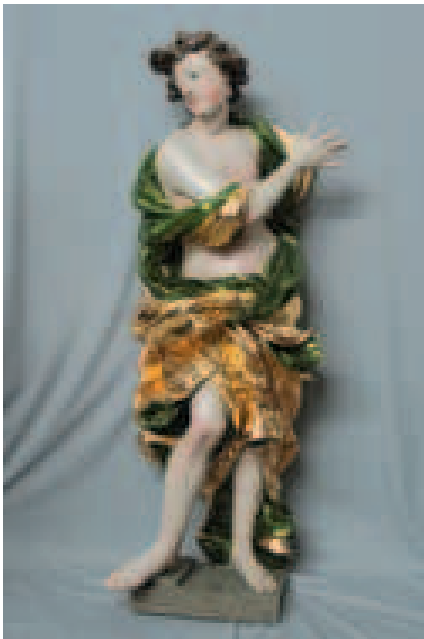
Anděl z oltáře sv. Barbory. Stav po restaurování. / Angel from the altar of St. Barbara, after restoration. Foto archiv autorky / author's archive

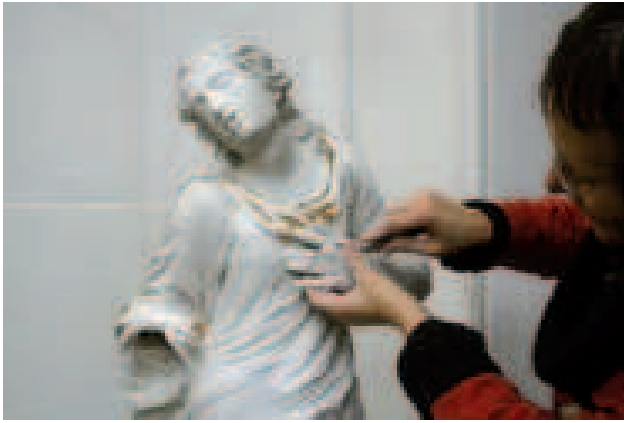
Anděl z kněžiště. Broušení křídového podkladu. /
Angel from the presbytery. Smoothing the chalk
foundation. Foto archiv autorky / author's archive

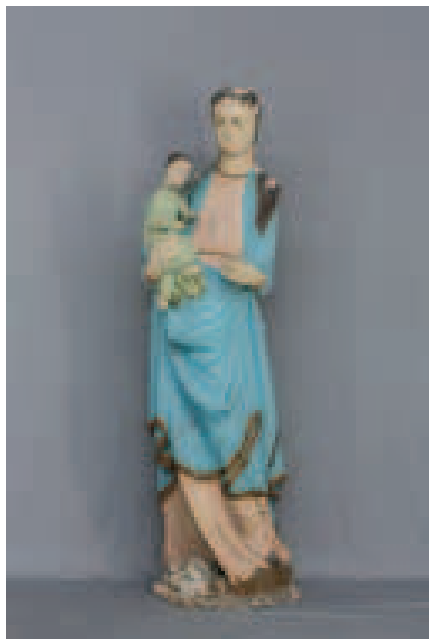
Madona z Klentnice. Stav před restaurováním. / Madonna from Klentnice, before restoration. Foto Markéta Pavlíková

celého vydlabaného otvoru zad. V hlavách zůstaly novodobé hřebíky po druhotném upevnění korun nebo svatozáří. Na podstavci se objevilo množství továrních hřebíků, ale i kované skoby přichycující plochou desku podstavce k soše. Projevovaly se četné sádrové doplňky v modelaci pláště, velké tmely podél hlavy a na ramenou Madony. Silná druhotná povrchová úprava na snímcích zakrývala stavbu dřeva.

žitá je informace o stavu poškození dřeva dřevokazným hmyzem. Nejvíce je napadena část v oblasti krku a ramenou Madony. V dolní části pláště a nohou Madony je dřevo v kritickém stavu. Objevilo se několik prasklin a míst se zcela rozdrčenou dřevní hmotou.

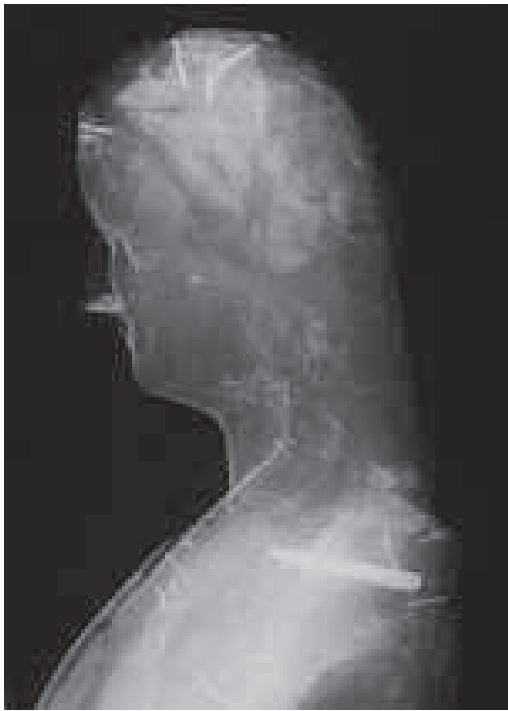
Počítačová tomografie a RTG snímek Madony z Klentnice. 1 – RTG snímek hlavy, viditelné kovové hřebíky, rozsáhlé tmely na vlasech a na ramenou; 2–6 – Počítačová tomografie: 2 – hlava (tangenciální řez), vsazený nos, suk na temeni hlavy; 3 – celek (topogram), viditelné kovové prvky; 4 – celek (tangenciální řez), čep v hlavě Ježíška, rozpadlé dřevo v dolní části; 5 – detail (axiální řez), nasazení levé ruky Madony na dřevěný čep; 6 – detail (axiální řez), nasazení pravé ruky Ježíška na dřevěný čep. / Computer tomography and an X-ray image of the Madonna from Klentnice. 1 – X-ray image of the head, visible metal nails, extensive areas of filler in the hair and shoulders; 2–6 – Computer tomography: 2 – head (tangential cross-section), mounted nose, knot at the nape of the head; 3 – overall view (topogram), visible metal elements; 4 – overall view (tangential cross-section), pin in the head of the infant Jesus, destroyed wood in the bottom section; 5 – detail (axial cross-section), mounting the left arm of the Madonna on a wooden pin ; 6 – detail (axial cross-section), mounting the right arm of the infant Jesus on a wooden pin.

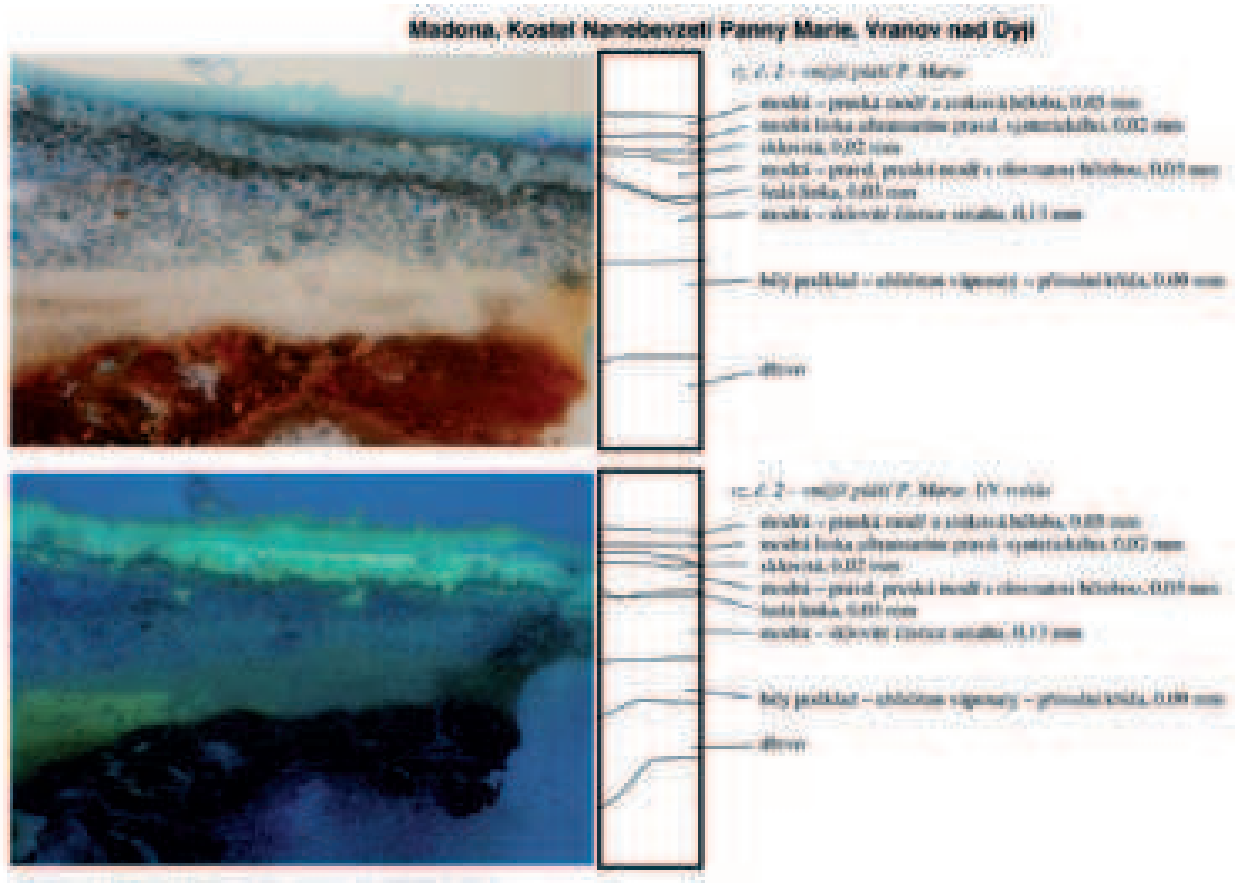
Laboratorní průzkum. Vnější plášť Madony (vzorek č. 2). / Laboratory investigation. Outer mantle of the Madonna (sample No. 2). Foto Markéta Pavlíková

A total of 15 samples were gradually taken for laboratory examination to compare the chalk foundation, which in most samples consisted of five layers of natural chalk. The pigments forming the last surviving coloured layer are malachite, enamel, red ochre, leaded white, vermilion, plate gold and silver with a layer of red organic lacquer. The occurrence of enamel in the last surviving layer provides evidence that the polychromy is not original as enamel began to be used after the second half of the 16th century. The intermediate layer used on most surfaces was calcium carbonate. The following layers contained pigments used from the 18th century – Prussian blue and others from the 19th century – zinc and barite white, artificial ultramarine, Schweinfurt green. It was not until the last phase of the restoration that we discovered minute fragments of probably original polychromy. On the right-hand side of the mantle of the Madonna, where polychromy is missing, we found a shard with gold, in the lower part of the red garment we can distinguish a fragment

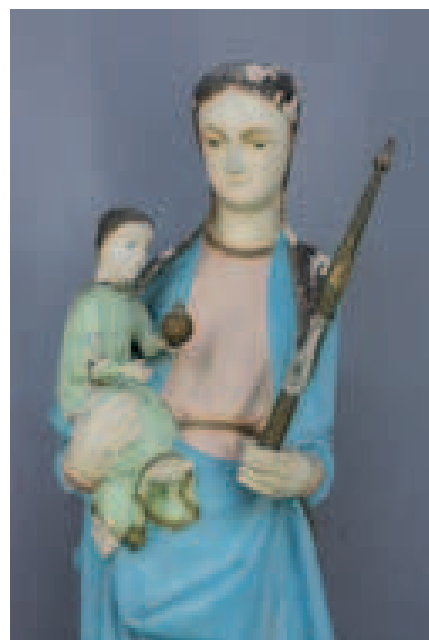
Madona z Klentnice. Stav před restaurováním. / Madonna from Klentnice, before restoration. Foto Markéta Pavlíková

by ligniperdous insects is essential. The greatest damage occurred in the area of the neck and shoulders of the Madonna. In the lower part of the mantle and legs of the Madonna the wood is in a critical state. A number of cracks and spots with completely crushed wooden mass were revealed.

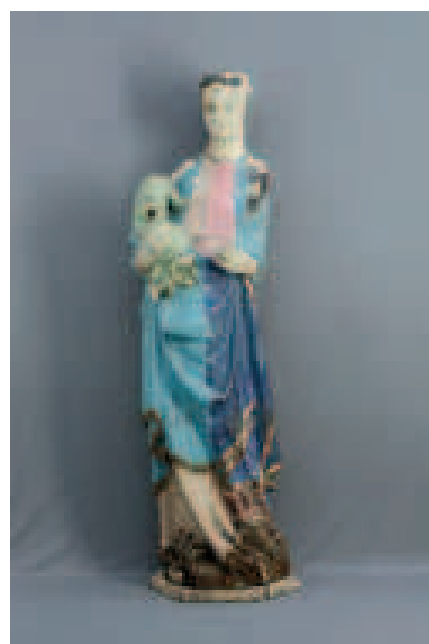
Postupné snímání přemalob. / Overpaint removal in stages. Foto Markéta Pavlíková

The removal of the overpaint layers was gradual in order to document the development in the appearance of the Madonna over time.⁹ The colour arrangement of the different parts was adhered to in all layers. The most striking was a layer with Prussian blue on the mantle of the Madonna. After removal that was performed in stages we discovered various modifications affecting the shape. The repair by Katharina Kundelius consisted in covering the exposed damaged wood by fine gauze with a layer of brittle plaster-in-Paris foundation. This was applied to the areas of the head of the Madonna and the infant Jesus, shoulders, the under tunic on the chest down to the waist, right arm and both sides of the Madonna. The lower part of the garment of the Madonna including the base was covered as a whole and in many places was additionally modelled using plaster-of-Paris. A substantial intervention in the appearance of the Madonna was made within the first layer of overpainting with Prussian blue (after 1750 at the earliest), when the headscarf and the crown of the Madonna were removed together with wood. The hair of the infant Jesus was cut off. The facial expression and the shape of the nose were probably modified in both figures. The folds of the scarf with remaining polychromy were found on the head of the Madonna under a layer of fillers. A tail of the white scarf with

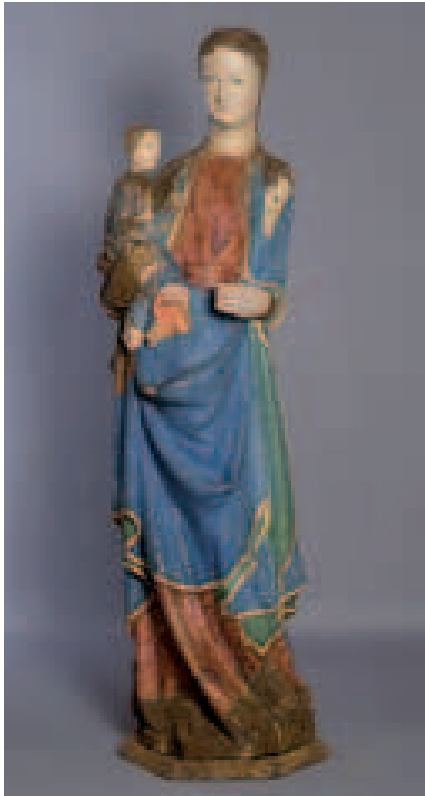
Madona z Klentnice. Stav po restaurování. / Madonna from Klentnice, after restoration. Foto Markéta Pavlíková

After many debates concerning the extent of the removal of the secondary layers and the final appearance of the sculpture, we arrived at a compromise solution. Given that the wood is very dark and seriously attacked by woodworm, we partly stuck with the modification from 1900 in the upper section of the Madonna. This will achieve a unity between the completely preserved drapery with the upper, more damaged part. The

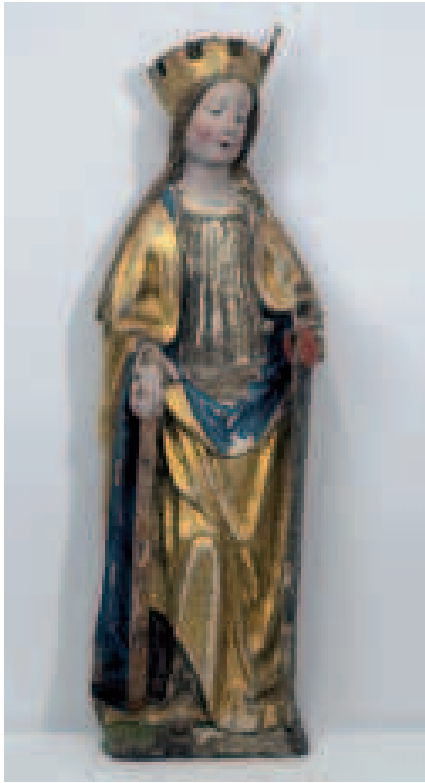
Sv. Kateřina z Vardø. Stav po restaurování. / St. Catharine from Vardø after conservation. Foto archiv autorky / author's archive

The first pictures taken for the museum show excessive cleaning traces and over-painting of the crown, the face, the inside of the cape, the hands, the sword handle and partly the stand. Four tacks of the crown were missing, as well as two of the spikes from the wheel and the upper sword handle. The surface showed areas with abrasions from strong cleaning. The over-painting is flaking badly especially on the face and gives therefore a somewhat sad impression.

The gilded cape exterior and the silver of the sword have a glue coating that shows an excessive crack pattern. The tension in the glue layer is so high that the glue is peeling off the metal surface. Through the tension in the overlaying paint and glue, as well as through climate changes followed by changes in the wood dimensions, the ground, paint and metal areas show flaking or the beginning of flaking. The original is therefore endangered and conservation is essential.

Consolidation represented the first step in the conservation process of the sculpture of St. Catherine from the Vardø altarpiece. The consolidation had to be executed through dust, soot and the over-painting layer. Another difficulty was the three dimensionality of the sculpture. Most of the consolidation process was undertaken with the aid of a microscope. The consolidation medium was sturgeon glue in a concentration of 3 or 5 %. All areas with over-painting

were uncovered under the microscope. For the most part, uncovering was executed mechanically with a scalpel. In some parts the over-painted layer had to be softened with a solvent. The solvent was a 1:1 mixture of water and ethanol. The solvent mixture was applied with a cotton stick and after a short while removed with a scalpel under the microscope. The old glue layer over the gold and silver was strongly reduced with a 1:1 solvent mixture of water and ethanol. Thick layers of glue could be softened and lifted up with a scalpel before the solvent reached the metal layer. The hair was especially fragile and was therefore consolidated and only very lightly cleaned. The uncovering of the azurite areas was difficult and extremely time-consuming, since both the over-painting and the original azurite layer were coarse.

The altarpiece with the sculpture of St. Catherine is on display at the museum. The conservation could stop after the consolidation, cleaning and uncovering. The reconstruction of the missing parts and the reintegration of the missing metal and paint areas were not seen as desirable. The sculpture presents a clear and visible testimony to a long history.

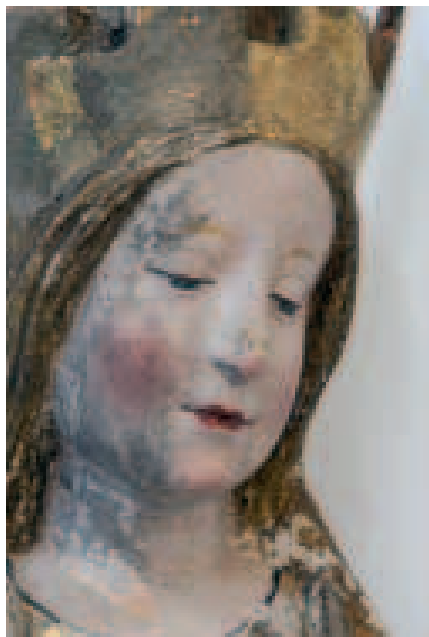
Sv. Kateřina z Vardø. Detail hlavy z průběhu restaurování. / Detail of the head of St. Catharine during conservation. Foto archiv autorky / author's archive
